OPS BULLETIN

DRIVING IN TBIT BAGROOM/SAFETY AWARENESS

No. 077
February 10, 2018

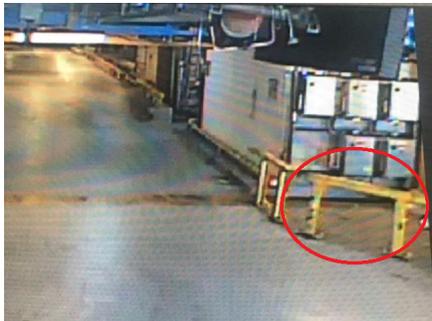
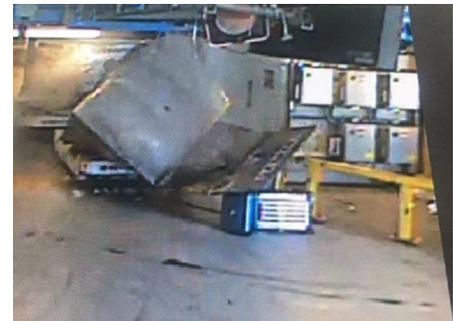
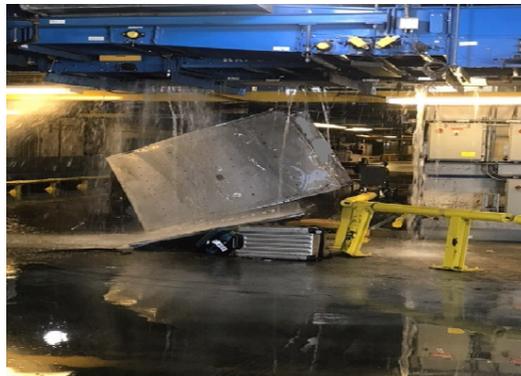
Background: On the afternoon of February 8th 2018, a service provider was driving 4 containers full of bags for inbound passengers to its assigned inbound carousel drop off point. The driver entered the bagroom from the south ramp level and was traveling North into the drive aisle. As the driver made a slight left into the inbound drop-off belt drive aisle, there was not enough clearance for the 4th container. This resulted in the right side of the dolly forcefully striking a yellow safety bollard

Impact: Upon impact the container struck an overhead sprinkler, became disengaged from the secured equipment, and caused significant damage to the container. The container also became unlocked and the passengers bags spilled onto the ground. In a matter of minutes due to the broken sprinkler, the immediate area became flooded thus damaging waiting passengers bags, and shortly after, flooding the CIQ (Customs Immigration and Quarantine) and Inbound Carousel areas as well. Carousel 2 and Carousel 4 had to be placed out of service for a few days until all equipment was dry and deemed safe to operate. A section of the BHS also had to be removed from service for the remainder of operational hours.

Root Cause: Airline Service Provider should have used more caution when entering the area by driving at a slower speed and making sure there was enough clearance for all equipment

Action Required: Airlines and Service Providers are kindly asked to immediately brief all staff regarding bagroom procedures related to the movement of ULD containers. Watch vehicle/equipment speed and always be aware of your surroundings.
